Subject: Boeing EQA Report - Aero Mexico 737-800 XA-ADV Radome Damage on
Approach Tijuana, Mexico, 12 Dec 2018

Equipment Quality Analysis Report

TO: Air Safety Investigations (ASI) **EQA NUMBER:** AS12941

SUBJECT: *Radome Damage on Approach*

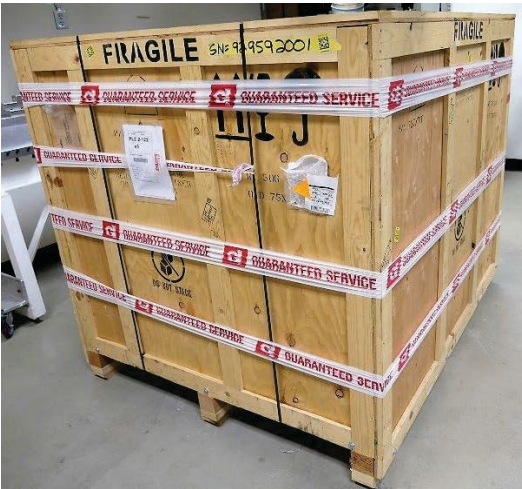
Figure 2 – Radome shipping container

Overviews of the radome as received by EQA are shown in Figure 2 and Figure 3. The information stamp on the interior of the radome is shown in Figure 4.
